BOARD OF INQUIRY FINAL REPORT DATED 20 JUN 06

**AIRCRAFT CRASH – LYNX AH MK 7 (XZ614)
OF 847 NAS IN BASRA, IRAQ 06 MAY 06**

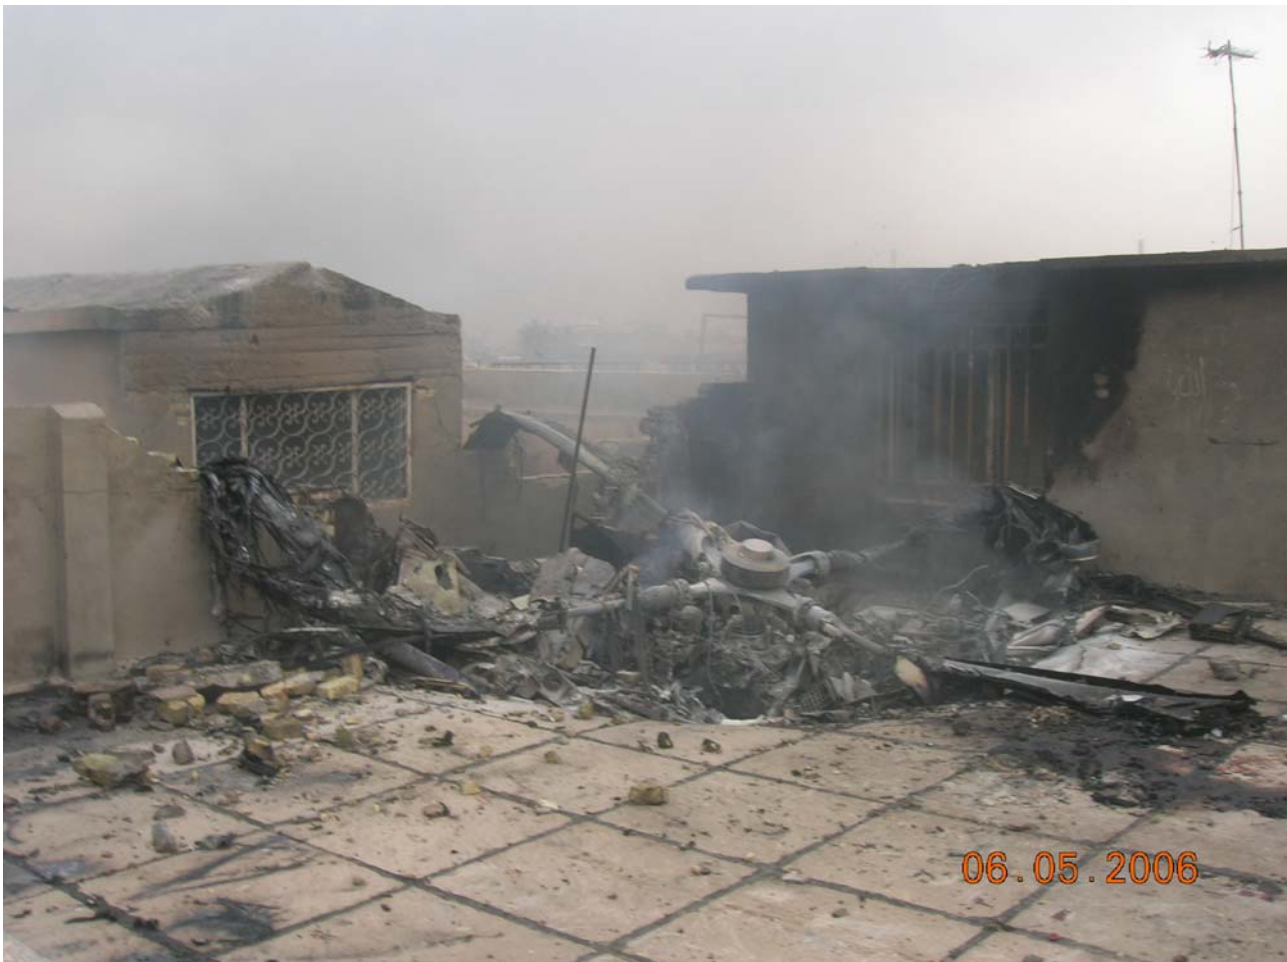
Figure 1 - Photographic Evidence of Crash Site

7. The Crash. Evidence from witness statements suggested that whilst overhead grid reference 38R QU 716788, a mid-air explosion occurred emanating from the starboard rear quarter of the aircraft, between the fuselage and the tail pylon [A350/351, A599, A615]. This partially severed the tail cone leaving it loosely attached to the fuselage [A599,A355]. The aircraft was engulfed by a fireball and plummeted to the ground, impacting at grid ref 38R QU 71147883. The main fuselage struck and was held by a reinforced concrete roof with the aircraft wreckage orientated facing an ESE'ly direction (Site 1). Much of the cockpit was severed at the point of impact with the building and fell a further 2 floors to a narrow enclosed alleyway below (Site 2). It is suspected that shortly before or during impact the tail cone fully separated from the fuselage. It came to rest on the roof of a separate building 3 metres in front of the fuselage (Site 3). This was the only area of the crash site not to burn. A diagrammatic representation of the crash site is at Annex C whilst photographic evidence is presented at Figure 1.

14. Post Crash Management. The crash site was confined to 3 principal areas; Site 1 contained the main fuselage, MRGB and engines on one reinforced concrete roof, Site 2 contained the cockpit in the base of a narrow alley and Site 3 contained the tail cone and TRGB on an adjacent similar roof on the other side of the alley **[Annex C]**. There was evidence of wreckage on the ground beneath the point of the initial explosion but the local population largely collected this wreckage with only a few pieces recovered by the investigators. Following the crash, the fuselage and cockpit section were ablaze, while the tail section was not. The strength of the building's roof withheld the impact within a 1.2 m deep crater. Basra City Battle Group (BCBG) were informed of the crash within 5-6 minutes of the event **[BG Comd Net radio log – Enclosure 9]**, and quickly deployed to the area. The local authorities were the first on the scene and the Iraqi Fire Service extinguished the fire within approximately 45 minutes **[BP CCTV – Enclosure 10]**. At around the same time an inner and outer cordon was established by MND(SE), although there had been plenty of opportunity for local access to the wreckage **[Local TV news footage – Enclosure 11]**. Throughout the recovery phase, the cordon troops were subjected to sniper and mortar fire as well as blast and petrol bombs. Sizeable aggressive crowds continually harassed them, however they maintained the cordon throughout the night. This followed advice from JHF(I) Command that recovery of the wreckage would be crucial to the subsequent investigation and, more importantly, recovery of the bodies was essential. During the incident BCBG troops defended themselves with both baton rounds and small arms fire. Some UK military personnel sustained minor injuries and several civilians were reported killed in the post-incident riot.

17. Building Damage. The aircraft came down on top of a 2 storey Iraqi residential dwelling. The roof of the building (described here as floor 3) was constructed from steel reinforced concrete. The aircraft had partially penetrated the roof and was held in place by the steel reinforcing bars. Damage was sustained to the roof, a first floor room and ground floor windows. HQ MND(SE) is liaising with the owner of the building in accordance with local procedures.

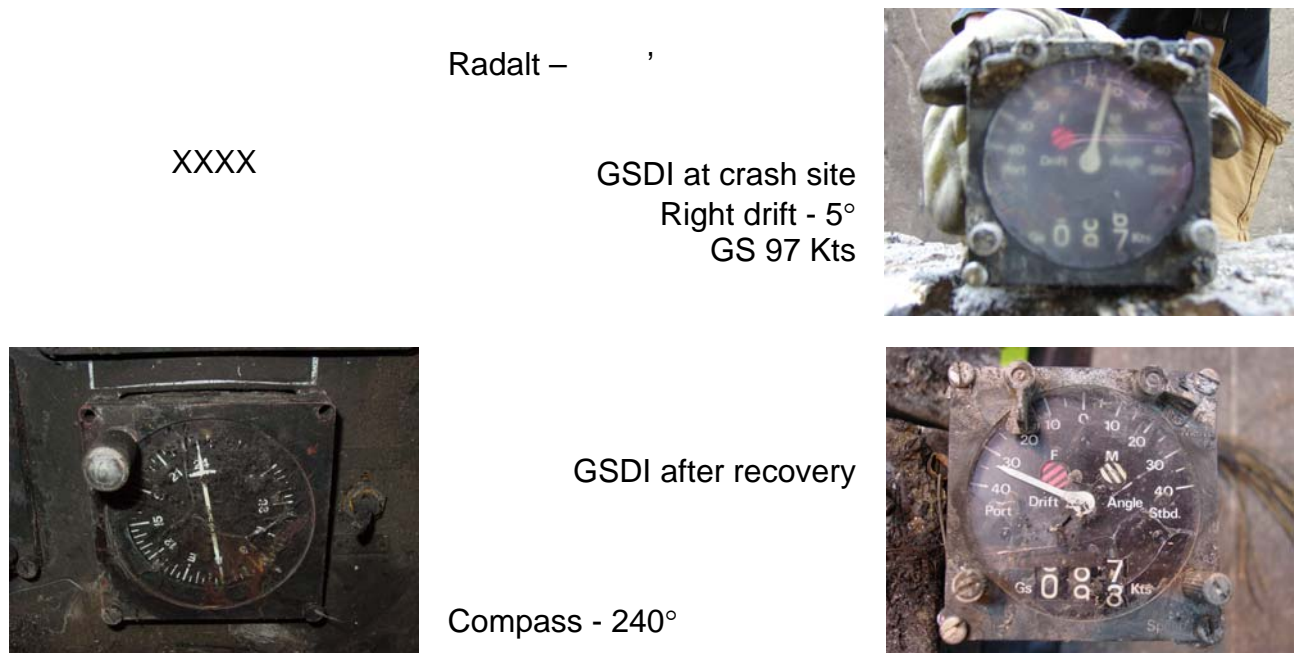
Figure 3 - Flight Instruments Recovered from Wreckage

tributary linking XXXXX to XXXXX [A369] passing to the S of the OSB (XXXXX). The aircraft maintained approximately level flight at medium level (estimated as approximately XXXXX ft agl) [A158, A191]. Immediately prior to the airborne explosion, the aircraft was observed by 2 witnesses to manoeuvre, including a bank to the left, but the degree of manoeuvring or the angles of bank achieved are not clearly defined [A603, A630]. During this period the aircraft's speed was described as both 'slow' [A595] and 'hovering' [A168]¹. Following recovery of the wreckage, the investigation focused on the technical evidence provided by the heading indicator, the radalt indicator and the Ground Speed and Drift Indicator (GSDI) as shown in Figure 3.

Advice from SMEs [RNFAIC (Field) Report – Enclosure 1] highlighted that these instruments are likely to have frozen at their indications at the time of the airborne explosion, showing that the aircraft was heading approximately 247°, at a height of approximately XXXXX ft agl and a groundspeed of approximately 98 kts (representing an airspeed of approximately 110 kts into a headwind of 12 kts).
